Close Out Documents

AP-70: 4621 Clayton St.

Asbestos Abatement and Structural Demolition

Structure Survey Assessment Report AP-70

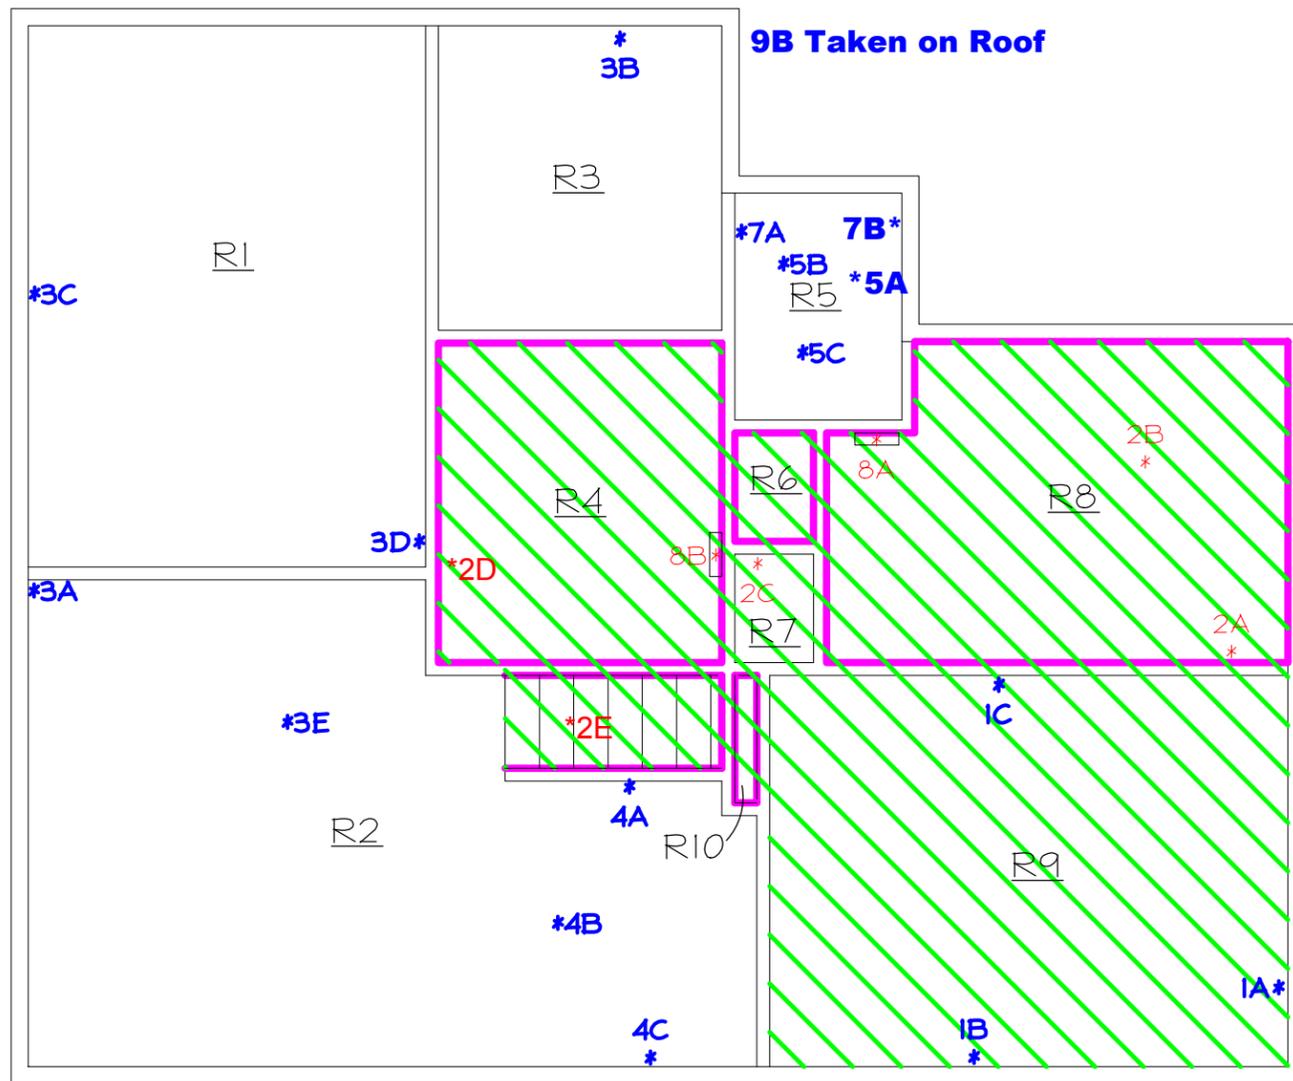
- = Positive Asbestos at Ceiling
- = Positive Asbestos at Walls
- 8A & 8B = Vent Boot Wrap Positive for Asbestos
- R1 = Room Numbers
- 4B = Asbestos Samples (Detect)
- 4B = Asbestos Samples (Non-Detect)

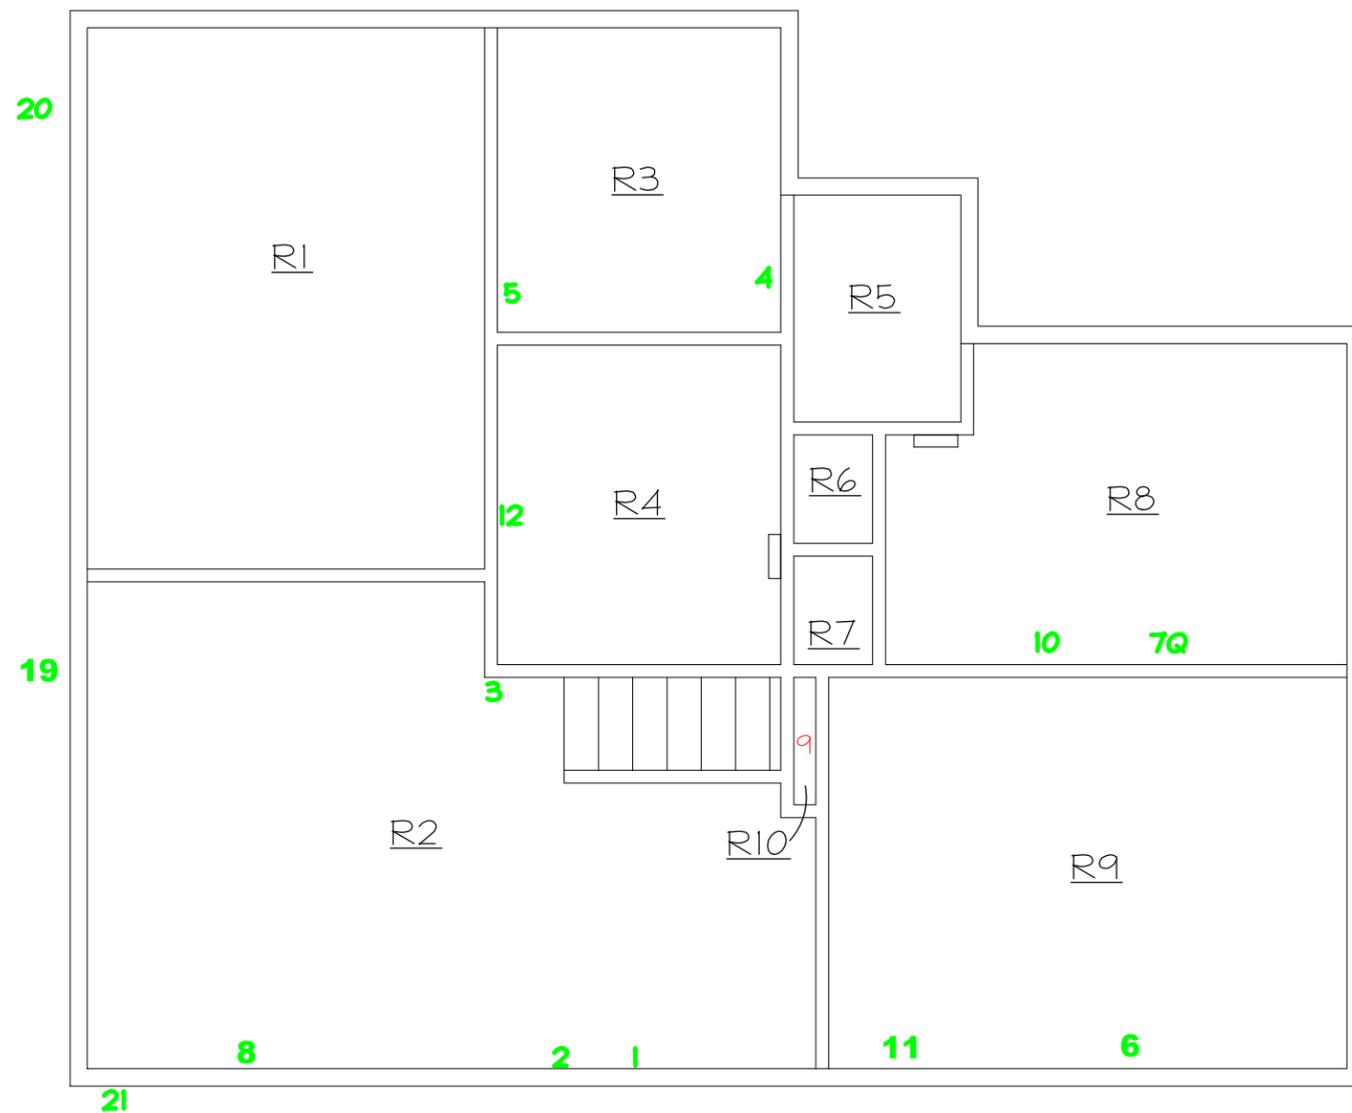
- R1 = Room Numbers
- 4 = Lead Base Paint (Detect)
- 4 = Lead Containing Paint (Detect)
- 4 = Lead Base Paint (Non-Detect)

While the TCLP results indicate that the waste stream is not characteristically hazardous with respect to lead content, LCP and LBP are still present in the building materials. Therefore, the contractor responsible for demolition of this structure is notified with receipt of this report of the presence or potential presence of LCP and/or LBP in the building materials that comprise the building. The contractor should also notify their employees of the presence of LCP or LBP prior to any disturbance, and make the OSHA publication number 3142-12R 2004 available to their workers. (“Lead in Construction”, http://www.osha.gov/Publications/osha_3142.pdf). The standards address topics such as permissible exposure limits (PELs) for workers, exposure assessment, protection of employees during assessment of exposure, employee notification, PPE, medical surveillance, along with other topics related to working with LCP and LBP.

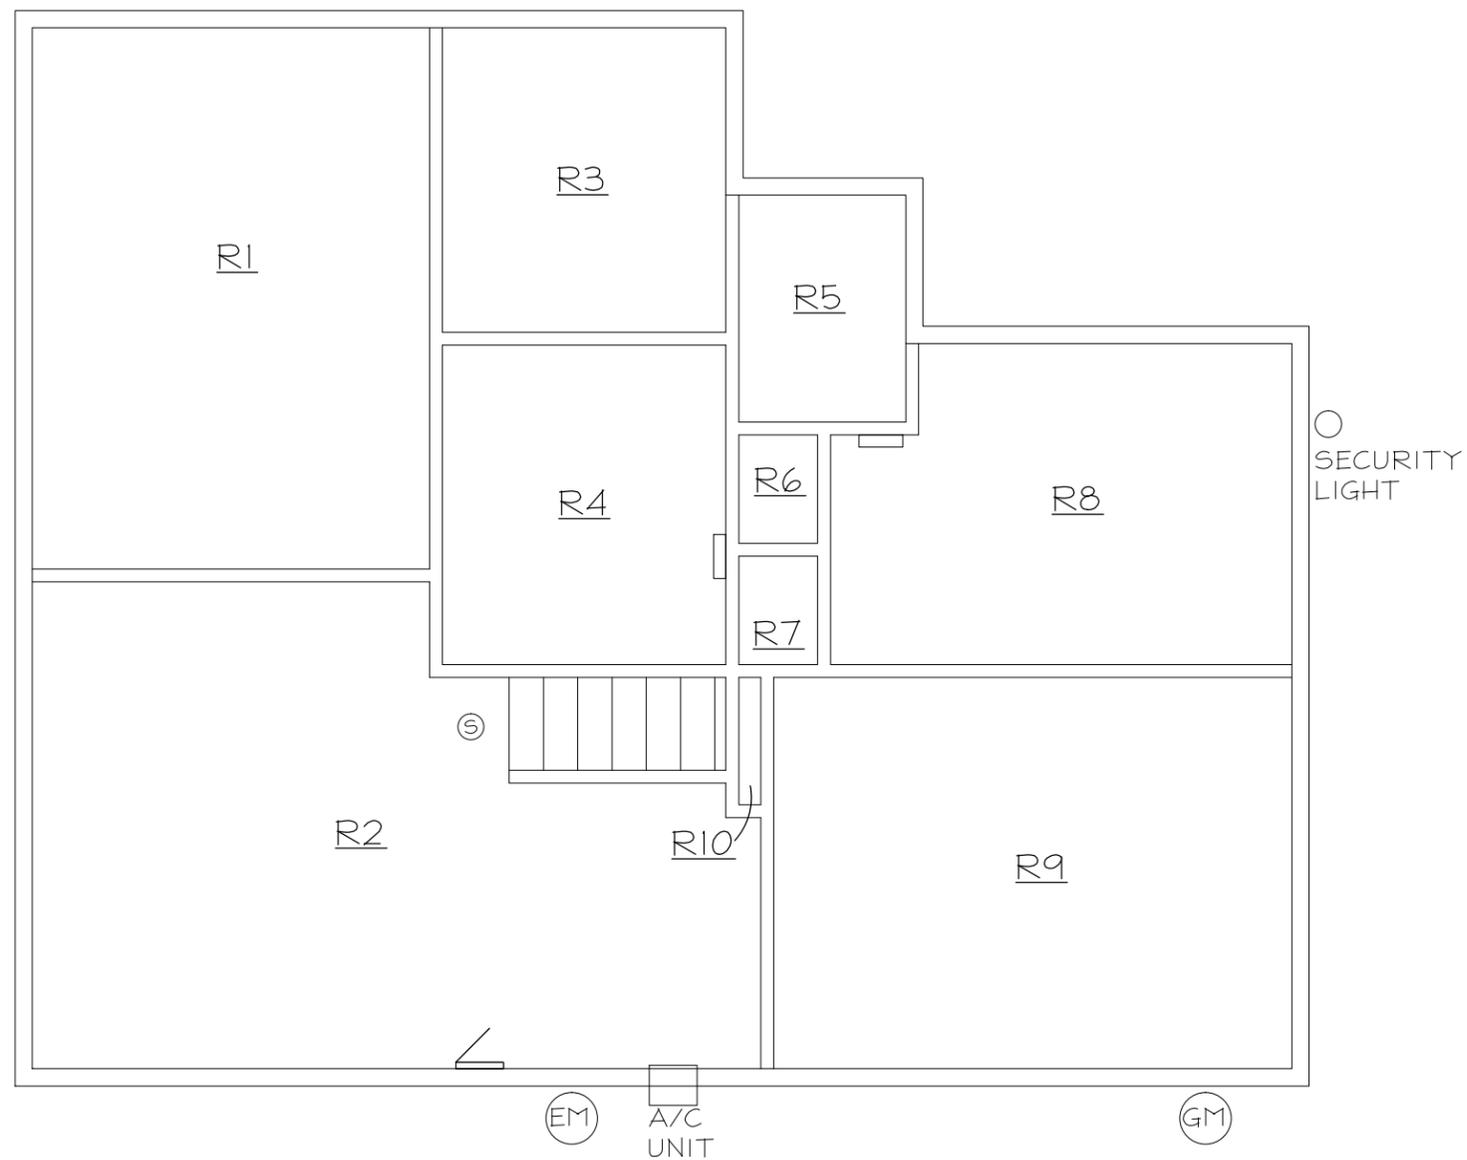
FIGURE 4 - Regulated Building Materials
CENTRAL 70 - Structure Survey Assessment Map
AP-70
 4621 Clayton Street, Denver, CO
 April 18, 2018
 ALL PHASE PROJECT NUMBER: 18-3066

Several suspect RBMs were visually identified throughout the structure. RBMs that are a cause of concern, when discovered, are discussed below. A complete list of the RBMs is presented in Table 3-3, and selected locations of the RBMs are depicted in Figure 4.

With regards to RBMs, it is likely that the ballasts in the fluorescent light fixtures do contain PCBs. Where a manufacturer's label is present indicating "no PCBs", the ballast can be disposed of with recyclable metal or with other municipal waste. During removal for disposal as part of the demolition activities, each ballast should be visually inspected for the manufacturer's label indicating "no PCBs". If the label does not have this notation, the ballast should be considered PCB-containing and should be disposed of as a hazardous waste in accordance with local, state, and federal regulatory guidelines. Refrigerators and Air Conditioning units contain freon; this will need to be reclaimed or taken to a facility capable of this activity. Mercury containing thermostats will need to be disposed of at a facility certified to take this type of material. The contractor should also carefully remove all associated fluorescent light tubes and compact fluorescent lights and recycle or dispose of these materials according to applicable regulations.

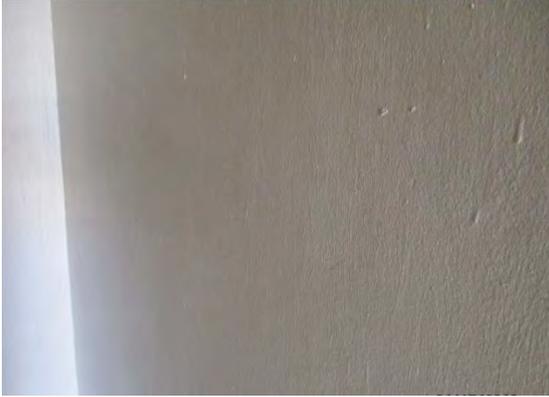
RACM - Smooth Textured Plaster

Samples Represented –
4621CL-R8-2A
4621CL-R8-2B
4621CL-R7-2C
4621CL-R4-2D
4621CL-STAIR-2E

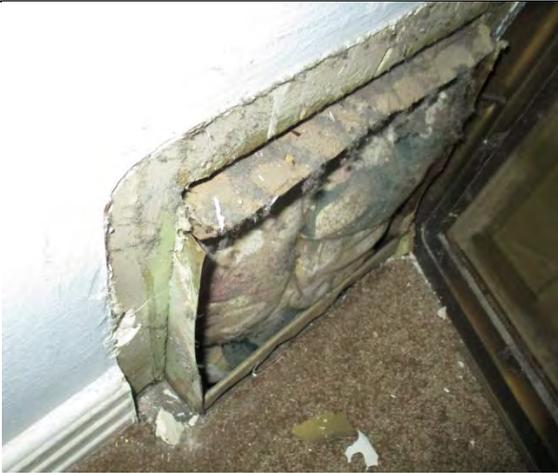
RACM – Vent Boot Wrap

Samples Represented –
4621CL-R8-8A
4621CL-R4-8B

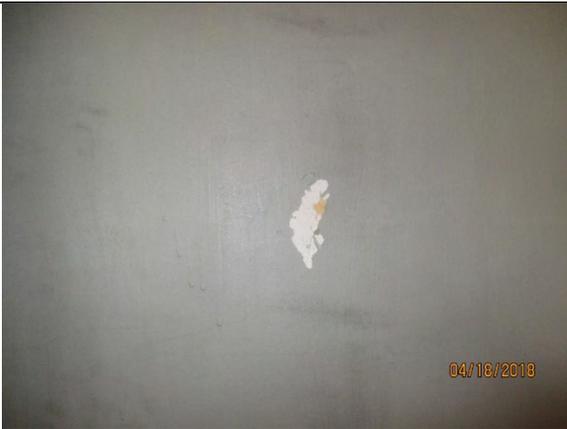
LCP - GRAY

Sample Represented –
4621-R10-9
